**Flood Control Project Maintenance
Levee Inspections****LMA District Cover Sheet****Spring 2014 Levee Inspection Results****Reclamation District No. 2031 Elliot**

Spring 2014 Levee Inspection Results

Reclamation District No. 2031 Elliot

Waterway			Bank	Unit Miles
Unit No. 01 Stanislaus River			Left	7.15
	Spring (March - May)	Summer (June - August)	(September - November) Fall	Winter (December - February)
Unit Maintenance Rating (Fall Only)				
Date of Inspection	05/08/2014 - 05/08/2014			
DWR Inspector	Maksim Khashchuk			
Accompanied By	Bob Buckmaster

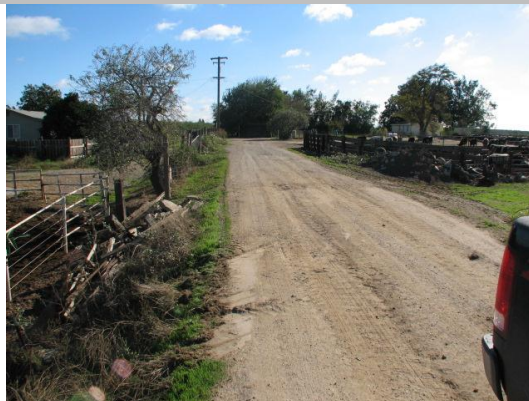
Photo 1 of 1 : mkhashch_s_20140428_00422.jpg

Fall 2009 photo looking upstream at beginning of unit 1. Water side to the left.

LM Start	0.04	Rating **	U	Issue No.	122
LM End	0.04	Issue Type +	En	Location *	WS
Category	Earthen Levee			GPS Latitude/Longitude	
				Start	End
Item	Encroachments			37.710016 °	37.710016 °
				-121.155803 °	-121.155803 °
DWR ID	DWR_RD2031_01_s _ 2014_122				
Action/Comments					
Debris

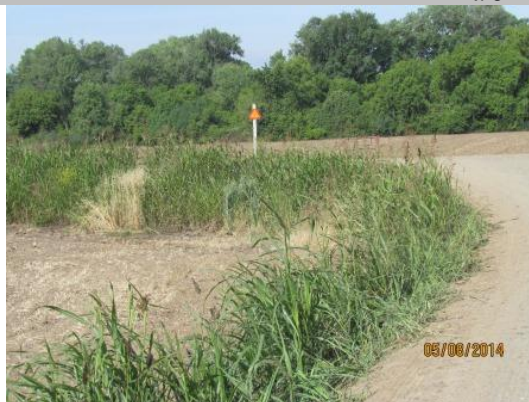
Photo 1 of 1 : mkhashch_s_20140512_01005.jpg

View of the tall vegetation on the landside levee slope.

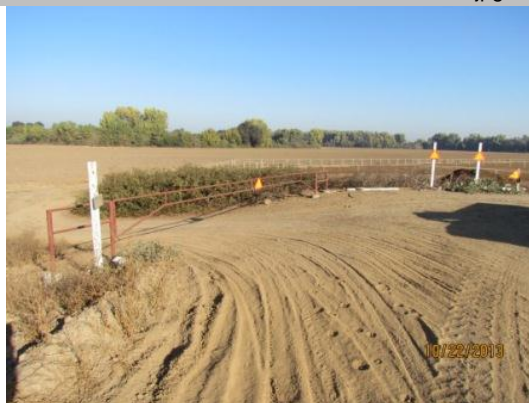
Photo 1 of 1 : mkhashch_s_20140428_00420.jpg

View of the gate at the waterside levee hinge.

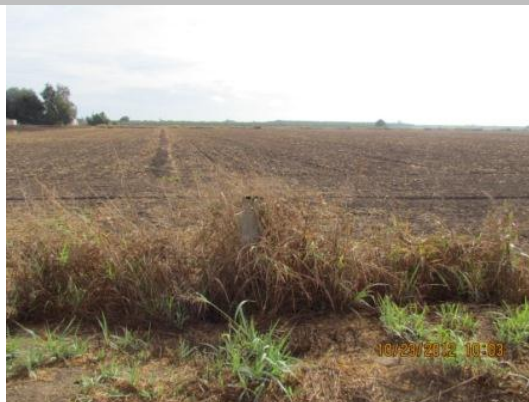
Photo 1 of 1 : mkhashch_s_20140428_00408.jpg

View of the pipe in landward slope of levee facing downstream.

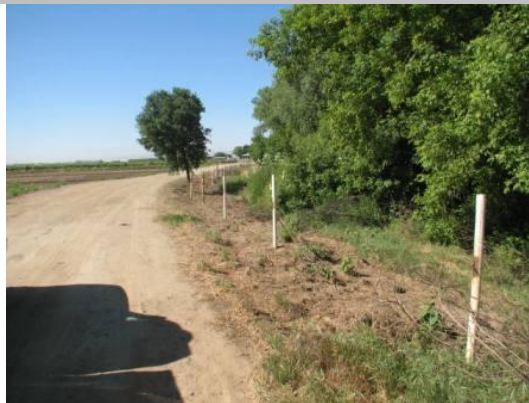
Photo 1 of 3 : mkhashch_s_20140428_00393.jpg

05/10/2011 Fence on waterside prevents access to waterside slope.

LM Start	0.34	Rating **	U	Issue No.	7 (cont)
LM End	0.52	Issue Type +	En	Location *	WS

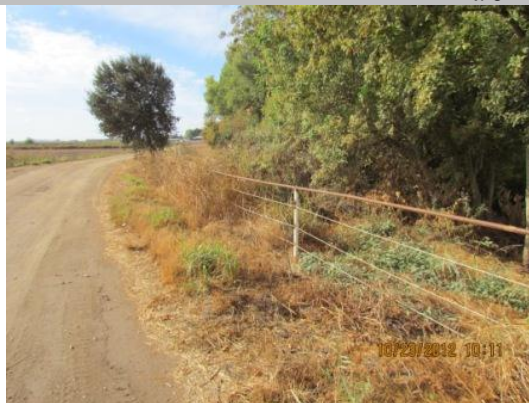
Photo 2 of 3 : mkhashch_s_20140428_00394.jpg

View of fence on waterside slope facing downstream.

LM Start	0.34	Rating **	U	Issue No.	7 (cont)
LM End	0.52	Issue Type +	En	Location *	WS

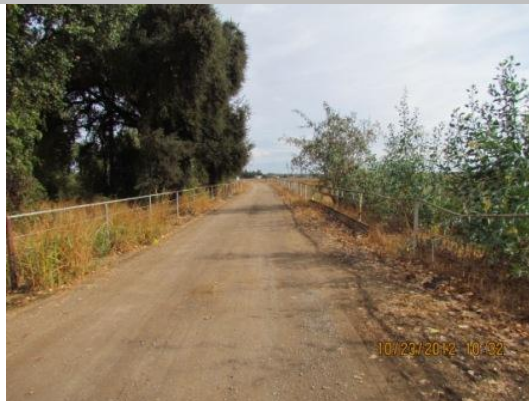
Photo 3 of 3 : mkhashch_s_20140428_00395.jpg

View of fence obstructing access to waterside slope. Facing upstream.

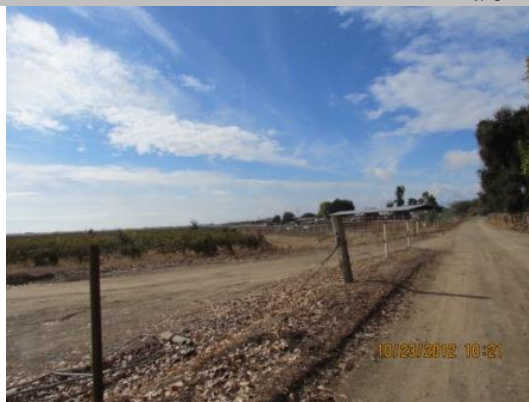
Photo 1 of 2 : mkhashch_s_20140428_00401.jpg

View of fence on landside levee shoulder facing downstream.

LM Start	0.45	Rating **	U	Issue No.	14 (cont)
LM End	0.52	Issue Type +	En	Location *	LS

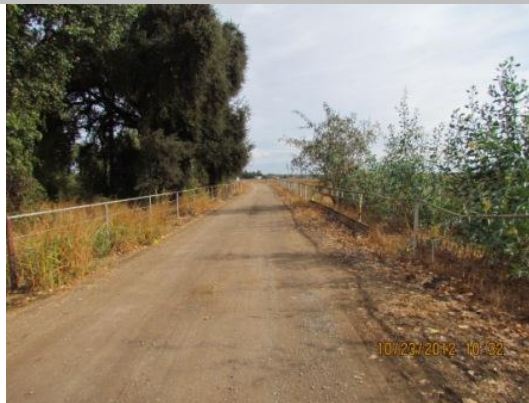
Photo 2 of 2 : mkhashch_s_20140428_00402.jpg

View of fence on landside levee shoulder obstructing access to landside slope. Facing upstream.

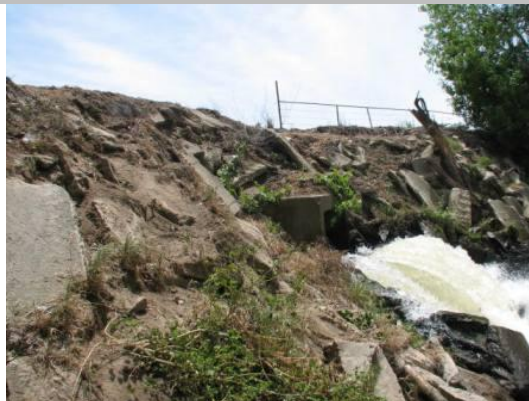
Photo 1 of 2 : mkhashch_s_20140428_00409.jpg

View of canal outlet on waterward slope facing downstream. 05/02/2012

LM Start	0.46	Rating **	U	Issue No.	32 (cont)
LM End	0.46	Issue Type +	En	Location *	WS

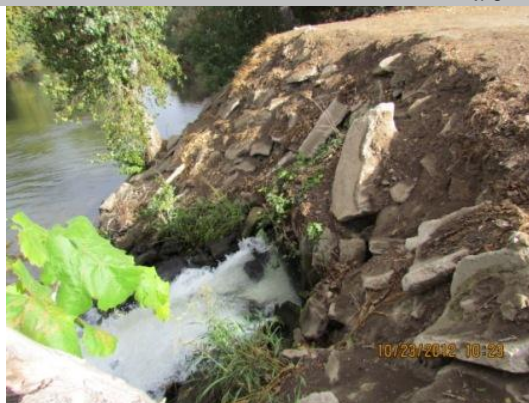
Photo 2 of 2 : mkhashch_s_20140428_00410.jpg

View of missing flap gate. Facing upstream.

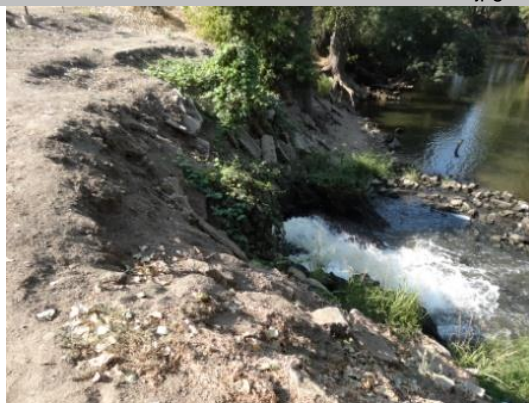
Photo 1 of 1 : mkhashch_s_20140428_00387.jpg

LM Start	0.47	Rating **	M	Issue No.	1
LM End	0.50	Issue Type +	Ma	Location *	WS
Category	Supplemental			GPS Latitude/Longitude	
				Start	End
Item	DWR Erosion Survey			37.704740 °	37.704740 °
				-121.159140 °	-121.159140 °
DWR ID	DWR_RD2031_01_s _ 2014_1				
Action/Comments					
Inspector Comments: 09/10/2013: No significant changes observed.

Looking downstream of the site. The irrigation outlet is operating. Debris is visible at the outlet.

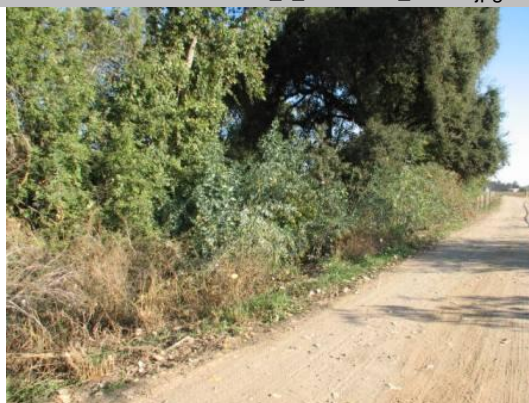
Photo 1 of 2 : mkhashch_s_20140428_00388.jpg

10/26/2011 Updated photo of waterside vegetation.

LM Start	0.52	Rating **	M	Issue No.	2 (cont)
LM End	0.52	Issue Type +	Ma	Location *	WS

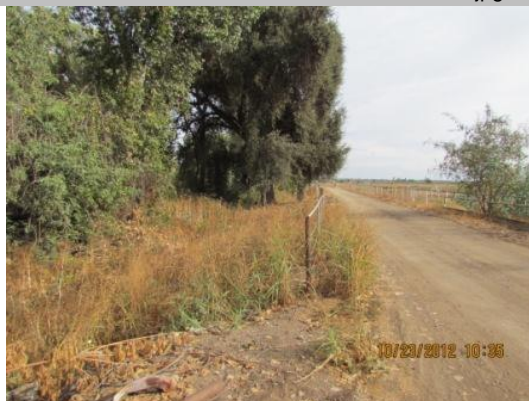
Photo 2 of 2 : mkhashch_s_20140428_00389.jpg

View of vegetation on waterside slope. Facing upstream.

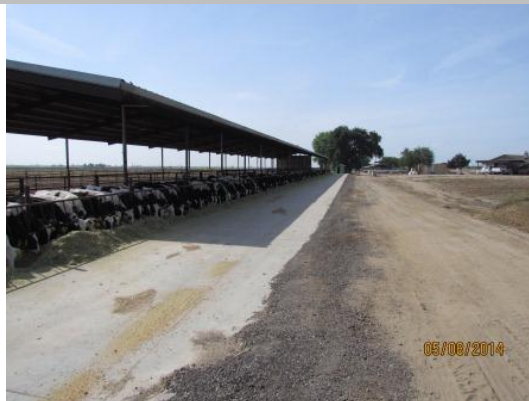
Photo 1 of 1 : mkhashch_s_20140512_01007.jpg

View of the new coral at the landside levee slope and toe.

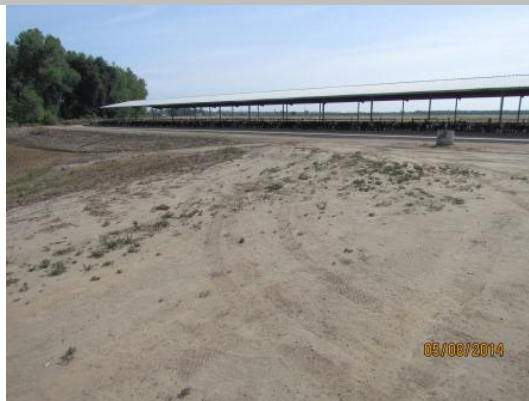
Photo 1 of 1 : mkhashch_s_20140512_01008.jpg

LM Start	0.57	Rating **	M	Issue No.	126
LM End	0.57	Issue Type +	En	Location *	WS
Category	Earthen Levee			GPS Latitude/Longitude	
				Start	End
Item	Encroachments			37.703394 °	37.703394 °
				-121.159713 °	-121.159713 °
DWR ID	DWR_RD2031_01_s _ 2014_126				
Action/Comments					
Material					
Inspector Comments: Levee built up with material from adjacent field.					
Unpermitted. The landowner has contacted CVFPB and started the					
permitting process.

View of the material placed on the waterside levee slope to build up the levee and increase the levee crown.

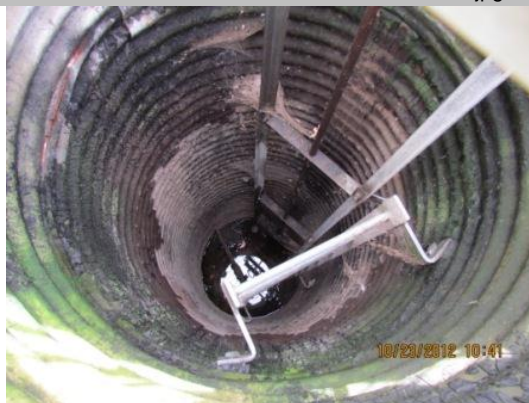
Photo 1 of 2 : mkhashch_s_20140428_00403.jpg

LM Start	0.57	Rating **	A/W	Issue No.	16
LM End	0.57	Issue Type +	En	Location *	WS
Category	Earthen Levee			GPS Latitude/Longitude	
				Start	End
Item	Encroachments			37.703120 °	37.703120 °
				-121.159798 °	-121.159798 °
DWR ID	DWR_RD2031_01_f_2012_16				
Action/Comments					
Pipe					
Inspector Comments: It appears that the pipe is in good condition and slide gate is operational.

View of slide gate and access ladder. Gate appears to be in good condition.

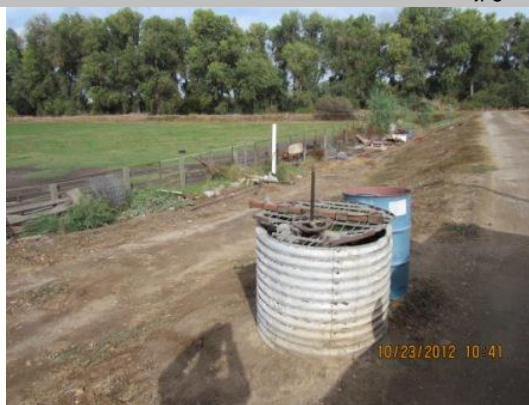
Photo 2 of 2 : mkhashch_s_20140428_00404.jpg

LM Start	0.57	Rating **	A/W	Issue No.	16 (cont)
LM End	0.57	Issue Type +	En	Location *	WS

View of the pipe gate valve location.

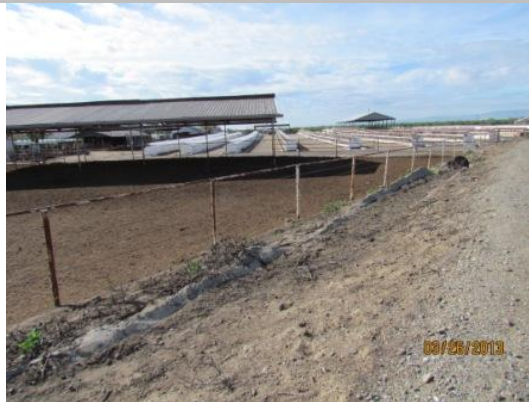
Photo 1 of 1 : mkhashch_s_20140428_00392.jpg

LM Start	0.64	Rating **	M	Issue No.	4
LM End	0.71	Issue Type +	En	Location *	LS
Category	Earthen Levee			GPS Latitude/Longitude	
				Start	End
Item	Encroachments			37.702814 °	37.701875 °
				-121.160562 °	-121.161670 °
DWR ID	DWR_RD2031_01_s_2012_4				
Action/Comments					
Fence

View of the fence at the landside levee toe.

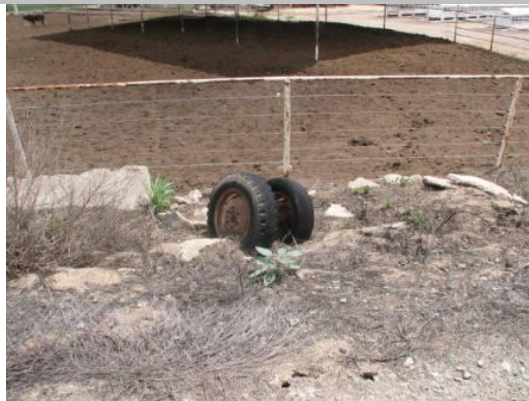
Photo 1 of 1 : mkhashch_s_20140428_00411.jpg

View of tractor wheels on landward slope. 05/02/2012

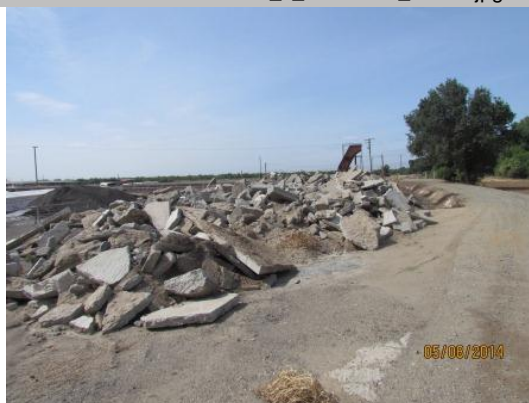
Photo 1 of 1 : mkhashch_s_20140512_01009.jpg

View of the concrete debris stockpiled at the landside levee toe.

LM Start	0.71	Rating **	U	Issue No.	127
LM End	0.71	Issue Type +	En	Location *	LS
Category	Earthen Levee			GPS Latitude/Longitude	
				Start	End
Item	Encroachments			37.702051 °	37.702051 °
				-121.161502 °	-121.161502 °
DWR ID	DWR_RD2031_01_s _ 2014_127				
Action/Comments					
Material Inspector Comments: Remove concrete stockpile from the levee toe easement.

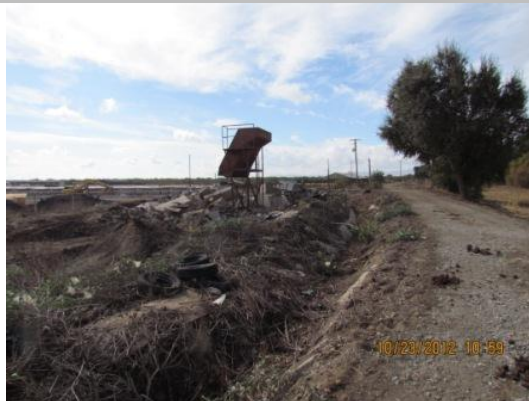
Photo 1 of 1 : mkhashch_s_20140428_00424.jpg

LM Start	0.72	Rating **	M	Issue No.	972
LM End	0.77	Issue Type +	En	Location *	LS
Category	Earthen Levee			GPS Latitude/Longitude	
				Start	End
Item	Encroachments			37.701906 °	37.701370 °
				-121.161661 °	-121.161986 °
DWR ID	DWR_RD2031_01_s _ 2012_972				
Action/Comments					
Ditch

View of the ditch on landside levee toe, facing downstream.

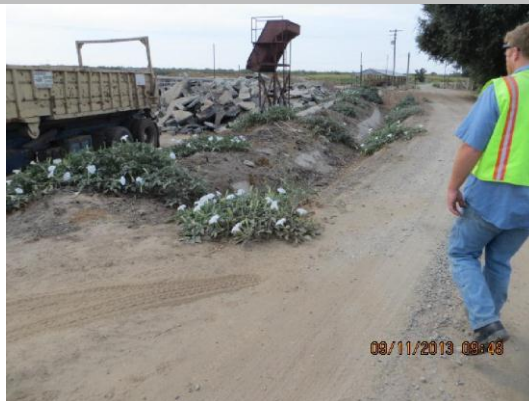
Photo 1 of 1 : UCIP_2156.jpg

LM Start	0.72	Rating **	M	Issue No.	108
LM End	0.72	Issue Type +	En	Location *	LS
Category	Supplemental			GPS Latitude/Longitude	
				Start	End
Item	DWR UCIP Field Study			37.701912 °	37.701912 °
				-121.161642 °	-121.161642 °
DWR ID	DWR_RD2031_01_s_2014_108				
Action/Comments					
Inspector Comments: FS_ID:20046					
EP_NO: N/A					
Repair Type:					
Crossing Status:					
UCIP Comments: Alfalfa valve on the WS toe is damaged.					
FIELD_STRUCT_DESC: 30-inch corrugated metal irrigation pipe					
through the levee 5.0-feet below the crown. Flashboard slots in					
concrete headwall on the landward side. Distribution box with alfalfa					
valve on the waterward side. Installed by USACE, 1966. Replaced a					
30-inch pipe at same location.					
FS Date: 9/11/2013

Concrete channel on LS shoulder.

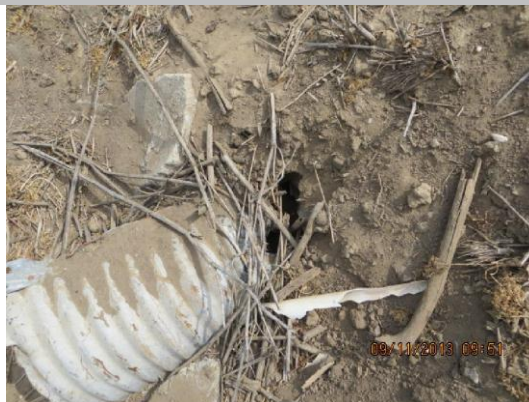
Photo 1 of 1 : UCIP_2158.jpg

LM Start	0.75	Rating **	M	Issue No.	109
LM End	0.75	Issue Type +	En	Location *	LS
Category	Supplemental			GPS Latitude/Longitude	
				Start	End
Item	DWR UCIP Field Study			37.701552 °	37.701552 °
				-121.161883 °	-121.161883 °
DWR ID	DWR_RD2031_01_s_2014_109				
Action/Comments					
Inspector Comments: FS_ID:20047					
EP_NO: N/A					
Repair Type:					
Crossing Status:					
UCIP Comments: This pipe appears abandoned and if so, should be done so appropriately.					
FIELD_STRUCT_DESC: 15-inch corrugated metal pipe through levee 4.0 feet below crown. Flashboard slots on the landward side. Installed by USACE 1966. Originally included in the 1968 O&M manual.					
FS Date: 9/11/2013

Hole in pipe at WS slope.

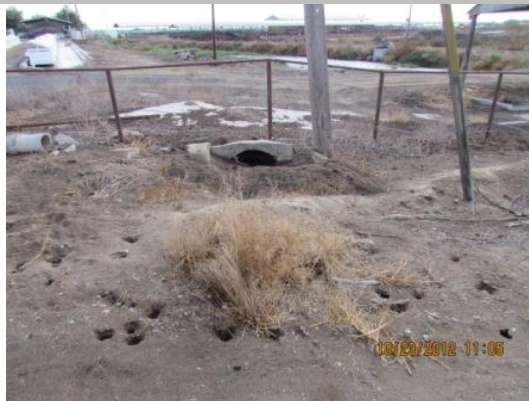
Photo 1 of 1 : mkhashch_s_20140428_00412.jpg

View of rodent burrows on landside slope.

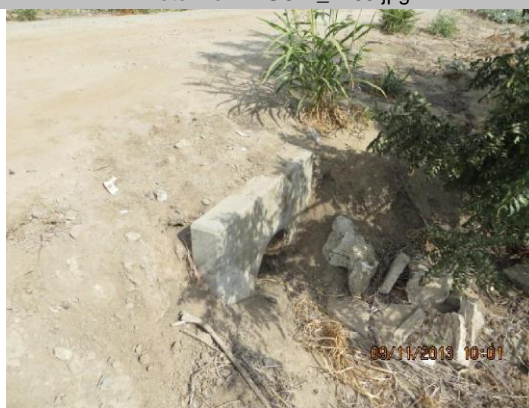
Photo 1 of 1 : UCIP_2163.jpg

LM Start	0.81	Rating **	M	Issue No.	110
LM End	0.81	Issue Type +	En	Location *	LS
Category	Supplemental			GPS Latitude/Longitude	
				Start	End
Item	DWR UCIP Field Study			37.700853 °	37.700853 °
				-121.162349 °	-121.162349 °
DWR ID	DWR_RD2031_01_s_2014_110				
Action/Comments					
Inspector Comments: FS_ID:20049					
EP_NO: N/A					
Repair Type:					
Crossing Status:					
UCIP Comments: Pipe appears abandoned as WS slope is covered with soil. If abadoned, it should be done so properly.					
FIELD_STRUCT_DESC: 24-inch steel pipe through levee 2.0-feet below the crown. Concrete headwall on both sides of levee crown.					
FS Date: 9/11/2013

Open pipe and headwall on LS slope.

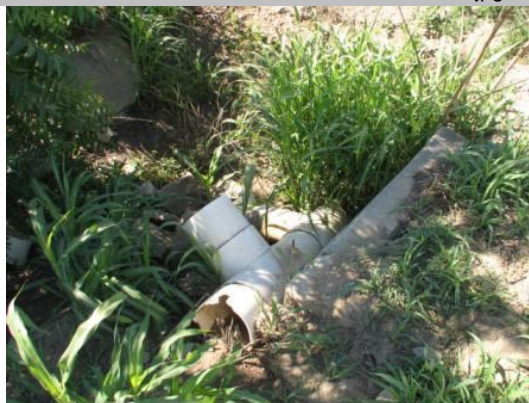
Photo 1 of 2 : mkhashch_s_20140428_00406.jpg

05/10/2011 PVC pipe pieces are obstructing opening to drain pipe.

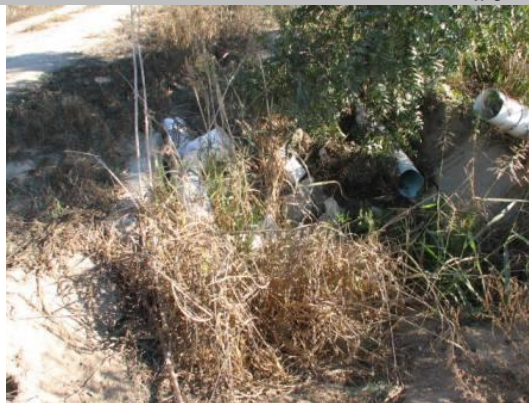
Photo 2 of 2 : mkhashch_s_20140428_00407.jpg

10/26/2011 Updated photo of PVC pipe pieces obstructing drain pipe, issue remains from Spring 2011 inspection.

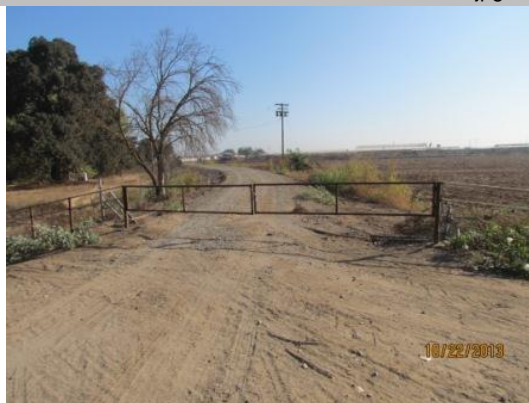
Photo 1 of 1 : mkhashch_s_20140428_00421.jpg

LM Start	0.93	Rating **	M	Issue No.	51
LM End	0.93	Issue Type +	En	Location *	CR
Category	Earthen Levee			GPS Latitude/Longitude	
				Start	End
Item	Encroachments			37.699727 °	37.699727 °
				-121.163919 °	-121.163919 °
DWR ID	DWR_RD2031_01_f _ 2013_51				
Action/Comments					
Fence

View of the gate across levee crown.

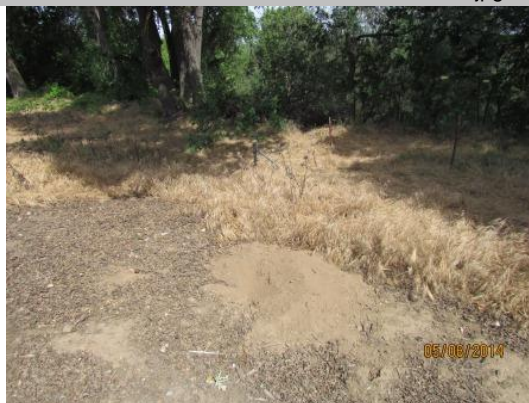
Photo 1 of 1 : mkhashch_s_20140512_01010.jpg

View of the rodent hole on the waterside levee slope.

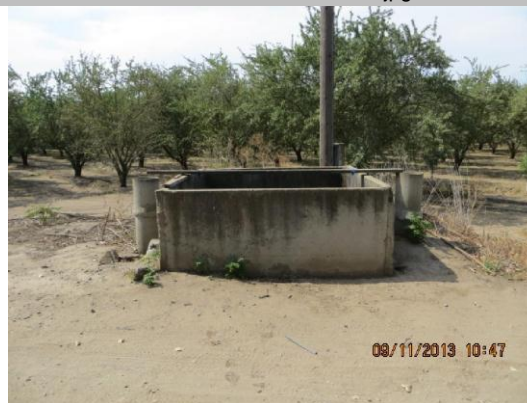
Photo 1 of 1 : UCIP_2166.jpg

LM Start	1.28	Rating **	M	Issue No.	111
LM End	1.28	Issue Type +	En	Location *	WS
Category	Supplemental			GPS Latitude/Longitude	
				Start	End
Item	DWR UCIP Field Study			37.699480 °	37.699480 °
				-121.169850 °	-121.169850 °
DWR ID	DWR_RD2031_01_s_2014_111				
Action/Comments					
Inspector Comments: FS_ID:20085					
EP_NO: N/A					
Repair Type:					
Crossing Status:					
UCIP Comments: Pipe corroded through at distribution box. Appears abandoned and should be done so properly.					
FIELD_STRUCT_DESC: 1 of 2: 12-inch steel pipe through the levee 3.3-feet below the crown. Pump missing from pile structure on the riverbank. Concrete distribution box on the landward side. Installed by USACE, 1966. Also included in 1968 O&M manual.					
FS Date: 9/11/2013

Concrete distribution box on LS shoulder.

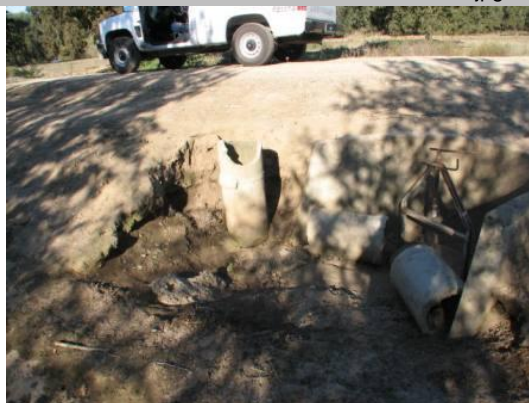
Photo 1 of 2 : mkhashch_s_20140428_00390.jpg

10/26/2011 Active erosion into the levee prism around irrigation standpipe.

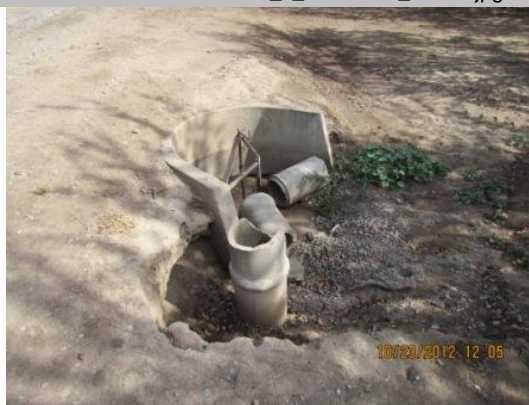
Photo 2 of 2 : mkhashch_s_20140428_00391.jpg

View of the erosion site on landside slope, facing upstream.

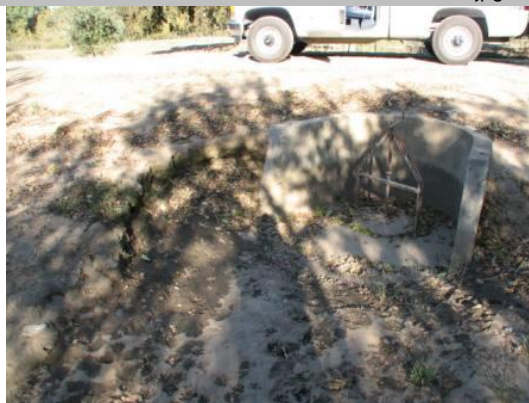
Photo 1 of 1 : mkhashch_s_20140428_00396.jpg

10/26/2011 Active erosion shown around irrigation inlet.

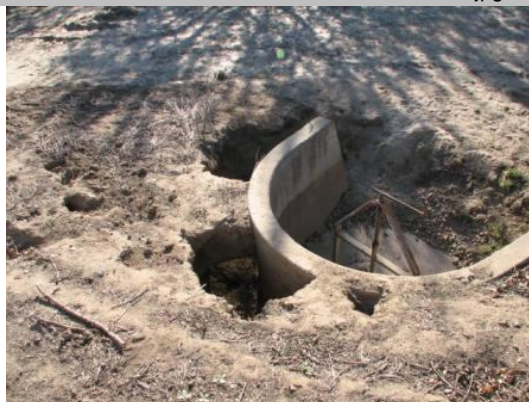
Photo 1 of 1 : mkhashch_s_20140428_00397.jpg

10/26/2011 Active erosion into levee prism around irrigation inlet.

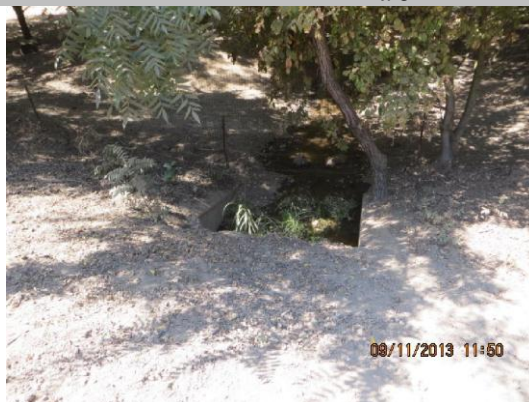
Photo 1 of 1 : UCIP_2174.jpg

LM Start	1.80	Rating **	M	Issue No.	112
LM End	1.80	Issue Type +	En	Location *	WS
Category	Supplemental			GPS Latitude/Longitude	
				Start	End
Item	DWR UCIP Field Study			37.696943 °	37.696943 °
				-121.177470 °	-121.177470 °
DWR ID	DWR_RD2031_01_s_2014_112				
Action/Comments					
Inspector Comments: FS_ID:20092					
EP_NO: N/A					
Repair Type:					
Crossing Status:					
UCIP Comments: Silt buildup at inlet and outlet.					
FIELD_STRUCT_DESC: 2 of 2: 24-inch corrugated metal pipe through the levee 9.5-feet below the crown. Concrete "U"-shaped headwalls on both ends. Flap gate on the waterward end. Installed by USACE, 1966. Also included in the 1968 O&M manual.					
FS Date: 9/11/2013

Concrete U-shaped headwall on WS toe.

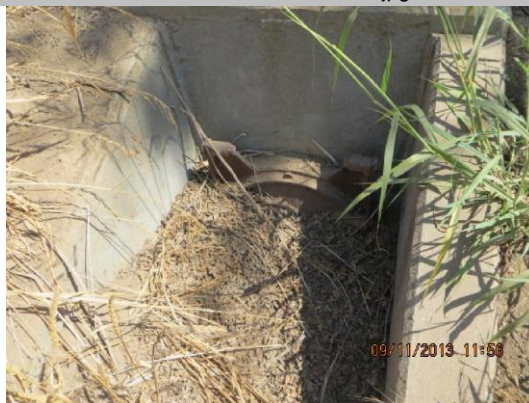
Photo 1 of 1 : UCIP_2187.jpg

LM Start	1.88	Rating **	M	Issue No.	113
LM End	1.88	Issue Type +	En	Location *	WS
Category	Supplemental			GPS Latitude/Longitude	
				Start	End
Item	DWR UCIP Field Study			37.695737 °	37.695737 °
				-121.177533 °	-121.177533 °
DWR ID	DWR_RD2031_01_s_2014_113				
Action/Comments					
Inspector Comments: FS_ID:20109					
EP_NO: N/A					
Repair Type:					
Crossing Status:					
UCIP Comments: If abandoned it should be done so properly if not, the pipe should be cleared of soil blockage.					
FIELD_STRUCT_DESC: *Abandoned* 24-inch pipe through levee 6.8 feet below crown. Concrete headwalls on both ends. Flap gate on the waterward end. Installed by USACE, 1966.					
FS Date: 9/11/2013

Flapgate on WS toe.

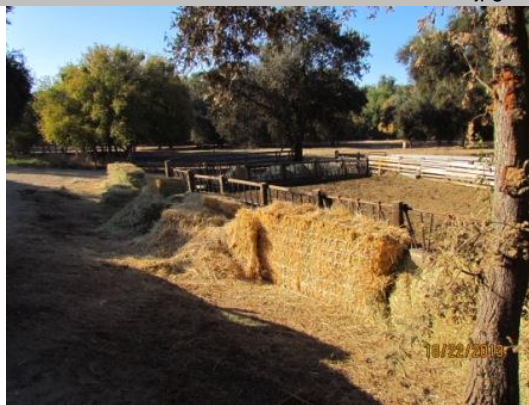
Photo 1 of 1 : mkhashch_s_20140428_00413.jpg

View of the hay bails at the landside levee toe.

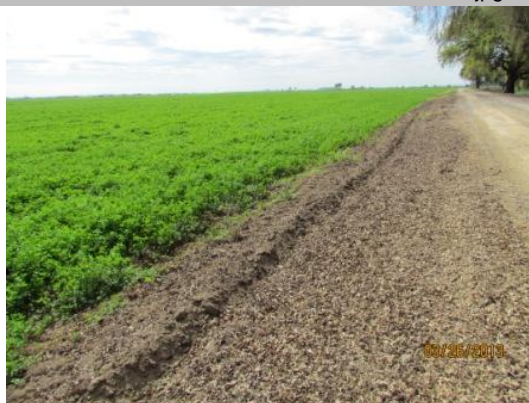
Photo 1 of 1 : mkhashch_s_20140428_00400.jpg

View of agricultural tilling at the landside levee toe.

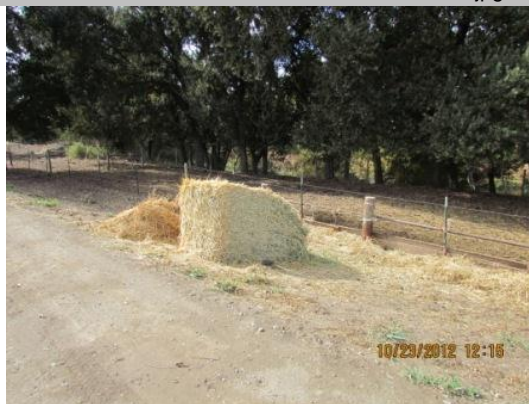
Photo 1 of 1 : mkhashch_s_20140428_00414.jpg

View of hay bales at toe of levee on waterward side, facing downstream.
05/02/2012

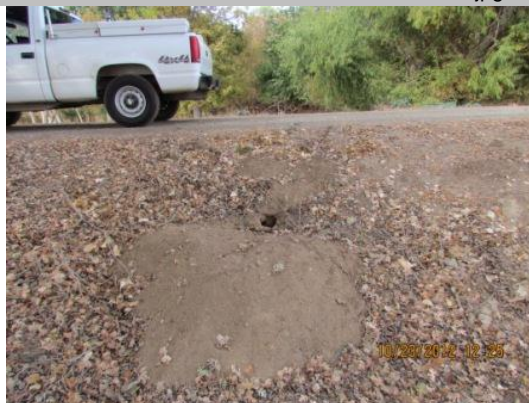
Photo 1 of 1 : mkhashch_s_20140428_00418.jpg

View of large animal burrow on landside slope with lots of material removed from the levee.

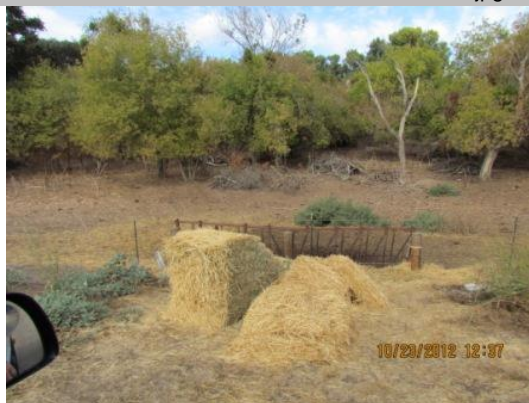
Photo 1 of 1 : mkhashch_s_20140428_00419.jpg

View of hay bales at toe of levee on waterward side, facing downstream.

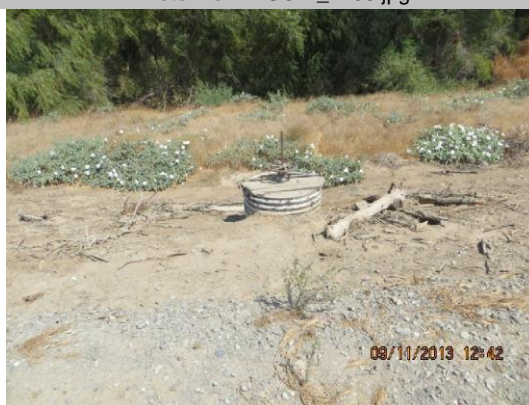
Photo 1 of 1 : UCIP_2238.jpg

LM Start	3.12	Rating **	M	Issue No.	115
LM End	3.12	Issue Type +	En	Location *	WS
Category	Supplemental			GPS Latitude/Longitude	
				Start	End
Item	DWR UCIP Field Study			37.688297 °	37.688297 °
				-121.190865 °	-121.190865 °
DWR ID	DWR_RD2031_01_s_2014_115				
Action/Comments					
Inspector Comments: FS_ID:20449					
EP_NO: N/A					
Repair Type:					
Crossing Status:					
UCIP Comments: Pipe appears to be abandoned and if so should be done so properly.					
FIELD_STRUCT_DESC: 24-inch corrugated metal pipe through levee 14.0 feet below crown. Slide gate in 36-inch corrugated metal pipe riser on the waterward slope. Originally included in the 1968 O&M manual.					
FS Date: 9/11/2013

Slide gate in CMP riser on WS slope.

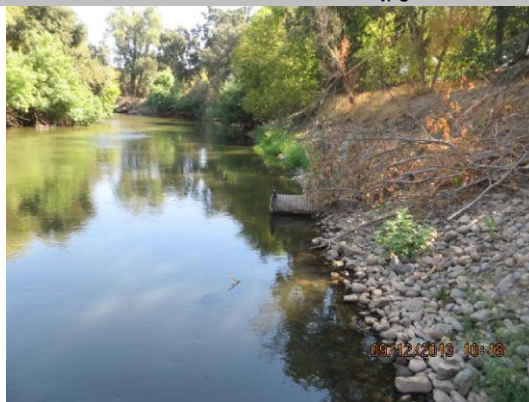
Photo 1 of 1 : UCIP_3331.jpg

LM Start	3.70	Rating **	M	Issue No.	116
LM End	3.70	Issue Type +	En	Location *	WS
Category	Supplemental			GPS Latitude/Longitude	
				Start	End
Item	DWR UCIP Field Study			37.689900 °	37.689900 °
				-121.198319 °	-121.198319 °
DWR ID	DWR_RD2031_01_s _ 2014_116				
Action/Comments					
Inspector Comments: FS_ID:23064					
EP_NO: N/A					
Repair Type:					
Crossing Status:					
UCIP Comments: Good candidate for video inspection.					
FIELD_STRUCT_DESC: 24-inch CMP drainpipe through levee 5.5 feet below crown. Flapgate visible at WS toe. Originally included in the 1968 O&M manual.					
FS Date: 9/12/2013

CMP pipe and flapgate visible at WS toe.

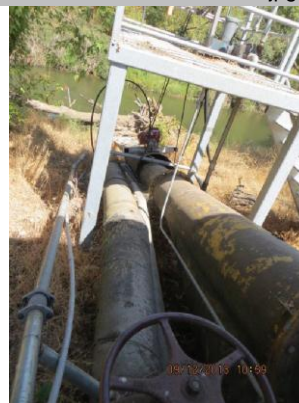
Photo 1 of 1 : UCIP_3252.jpg

LM Start	3.72	Rating **	M	Issue No.	117
LM End	3.72	Issue Type +	En	Location *	WS
Category	Supplemental			GPS Latitude/Longitude	
				Start	End
Item	DWR UCIP Field Study			37.689742 °	37.689742 °
				-121.198778 °	-121.198778 °
DWR ID	DWR_RD2031_01_s_2014_117				
Action/Comments					
Inspector Comments: FS_ID:22843					
EP_NO: N/A					
Repair Type:					
Crossing Status:					
UCIP Comments: No permit identified for this possible crossing.					
FIELD_STRUCT_DESC: 4-inch steel irrigation line through the levee at unknown depth. Pipe visible between larger irrigation pipes below slant pump on WS slope.					
FS Date: 9/12/2013

Pipe visible between larger irrigation pipes below slant pump on WS slope.

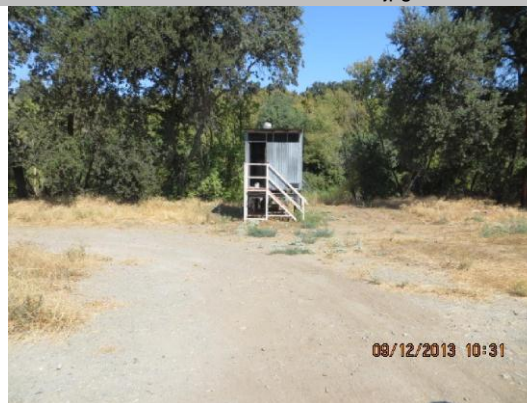
Photo 1 of 1 : UCIP_2262.jpg

LM Start	3.72	Rating **	M	Issue No.	118
LM End	3.72	Issue Type +	En	Location *	WS
Category	Supplemental			GPS Latitude/Longitude	
				Start	End
Item	DWR UCIP Field Study			37.689739 °	37.689739 °
				-121.198790 °	-121.198790 °
DWR ID	DWR_RD2031_01_s_2014_118				
Action/Comments					
Inspector Comments: FS_ID:20667					
EP_NO: N/A					
Repair Type:					
Crossing Status:					
UCIP Comments: Siphon breaker missing from LS shoulder. Fish screen and pipe end covered in debris that may cause damage to pipe.					
FIELD_STRUCT_DESC: 1 of 2: 20-inch steel irrigation pipe through levee 3.9 feet below crown. Slant pump in pump house mounted on piles on the berm. Siphon breaker in corrugated metal pipe riser on the landward shoulder. Service pole on the landward slope. 5'X5' concrete distribution box on LS toe with flapgate. Originally included in the 1968 O&M manual.					
FS Date: 9/12/2013

Slant pump in pumphouse on WS berm.

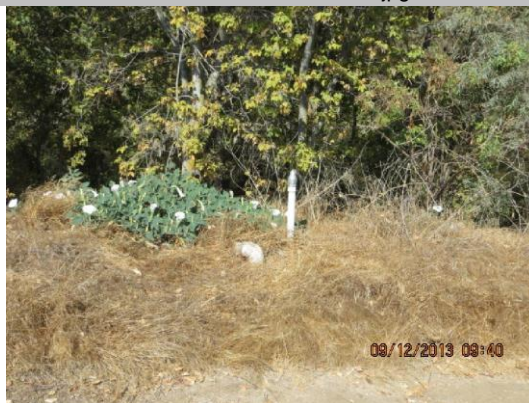
Photo 1 of 1 : UCIP_3258.jpg

LM Start	4.44	Rating **	M	Issue No.	120
LM End	4.44	Issue Type +	En	Location *	CR
Category	Supplemental			GPS Latitude/Longitude	
				Start	End
Item	DWR UCIP Field Study			37.686500 °	37.686500 °
				-121.207900 °	-121.207900 °
DWR ID	DWR_RD2031_01_s _ 2014_120				
Action/Comments					
Inspector Comments: FS_ID:22846					
EP_NO: N/A					
Repair Type:					
Crossing Status:					
UCIP Comments: No permit identified for this possible crossing.					
FIELD_STRUCT_DESC: 4-inch galvanized iron irrigation line visible on					
WS shoulder. May go through the levee at unknown depth. Vent on					
WS shoulder.					
FS Date: 9/12/2013

Pipe and vent visible on WS shoulder.

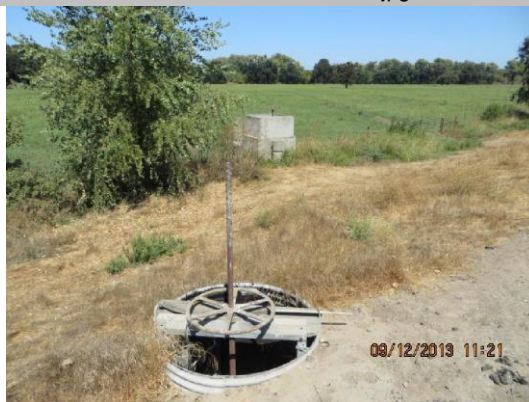
Photo 1 of 1 : UCIP_2274.jpg

LM Start	5.02	Rating **	M	Issue No.	121
LM End	5.02	Issue Type +	En	Location *	LS
Category	Supplemental			GPS Latitude/Longitude	
				Start	End
Item	DWR UCIP Field Study			37.680103 °	37.680103 °
				-121.212016 °	-121.212016 °
DWR ID	DWR_RD2031_01_s _ 2014_121				
Action/Comments					
Inspector Comments: FS_ID:20688					
EP_NO: N/A					
Repair Type:					
Crossing Status:					
UCIP Comments: CMP riser on WS slope is missing lid and may be a hazard.					
FIELD_STRUCT_DESC: 36-inch corrugated metal irrigation pipe through levee 11-feet below crown. Slide gate in 48-inch CMP riser on the waterward slope. 5'X5' Concrete distribution box 10 feet from the waterward toe. Underground irrigation system on the landside with concrete standpipes visible in field. Originally included in the 1968 O&M manual.					
FS Date: 9/12/2013

Slide gate in CMP riser on WS shoulder with concrete distribution box visible in background at WS toe.

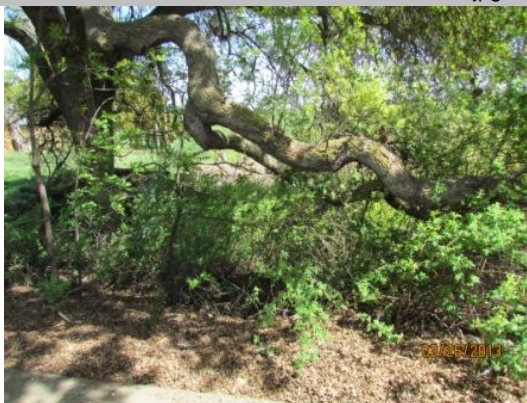
Photo 1 of 1 : mkhashch_s_20140428_00545.jpg

View of the tree limb obstructing visibility and access to the landside levee slope.

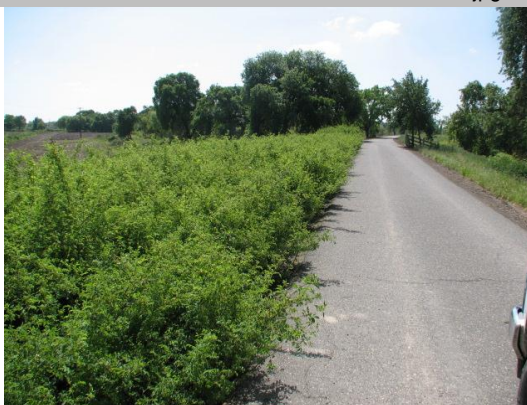
Photo 1 of 1 : mkhashch_s_20140428_00549.jpg

Wild rose on levee slope.

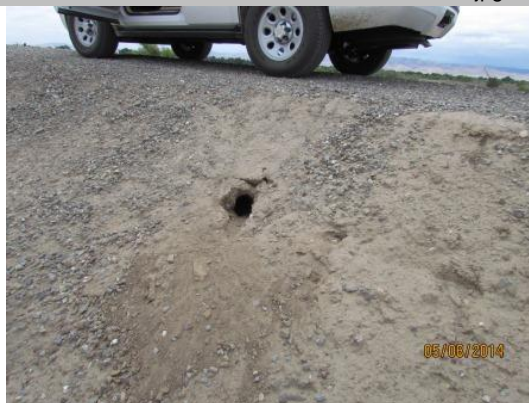
Photo 1 of 2 : mkhashch_s_20140512_01013.jpg

View of the large rodent hole on the landside levee slope.

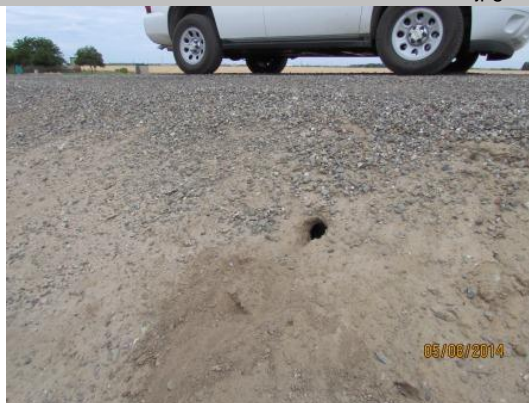
Photo 2 of 2 : mkhashch_s_20140512_01014.jpg

View of the large rodent hole on the waterside levee slope.

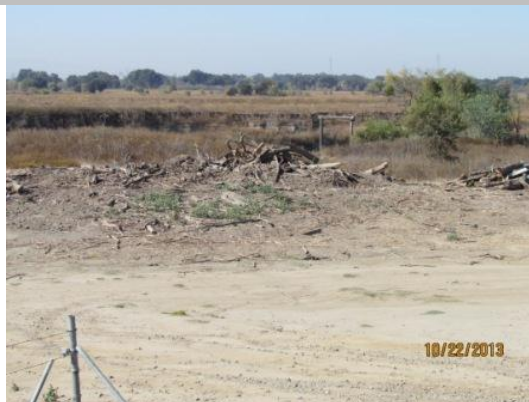
Photo 1 of 1 : mkhashch_s_20140428_00548.jpg

View of the debris pile in the floodway.

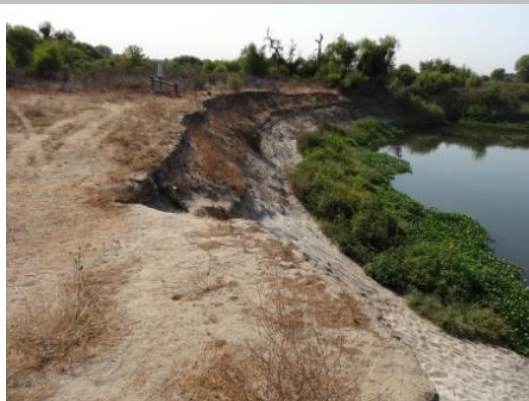
Photo 1 of 1 : mkhashch_s_20140428_00536.jpg

Looking downstream. The erosion has progressed toward levee.

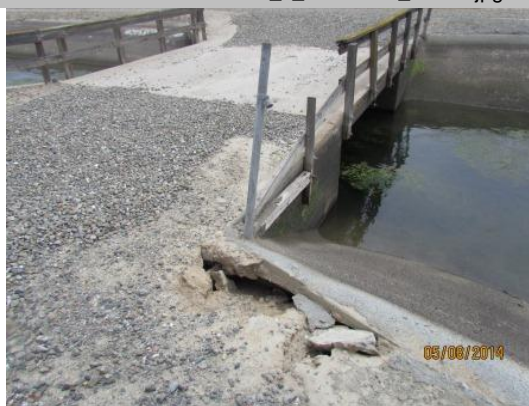
Photo 1 of 1 : mkhashch_s_20140512_01015.jpg

View of the slope instability at the waterside levee hinge.

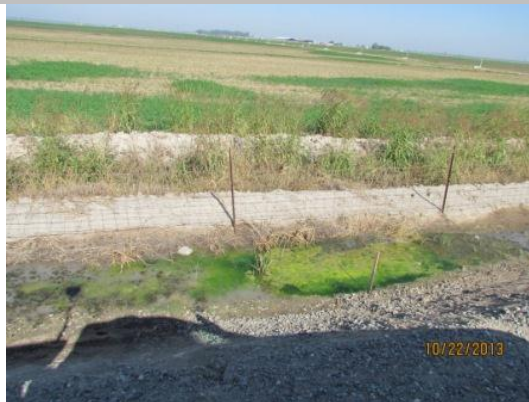
Photo 1 of 1 : mkhashch_s_20140428_00543.jpg

View of the seepage area at the landside levee toe.
